AVIATION INVESTIGATION REPORT
A01P0282

INPUT FREEWHEEL UNIT FAILURE

DWAYNE AIR 2000, LTD.
EUROCOPTER SA315B LAMA C-GXYM
SAWTOOTH MOUNTAIN, BRITISH COLUMBIA
08 NOVEMBER 2001

Report Number A01P0282

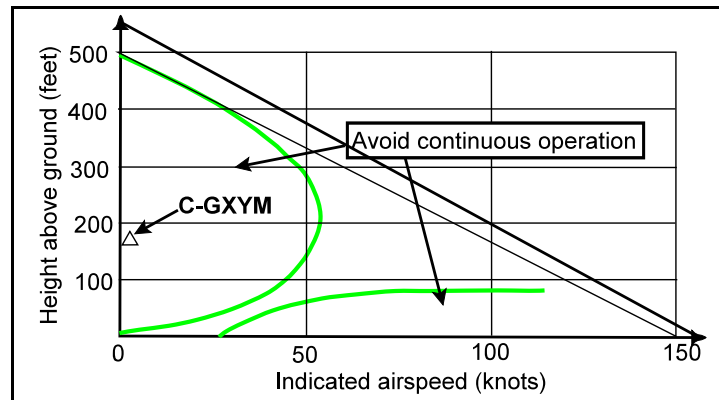
Figure 1. Speed-altitude graph (Eurocopter)

Section 4 (Performance) of the Transport Canada-approved rotorcraft flight manual (RFM) contains a speed-altitude graph outlining the in-flight parameters where pilots should avoid continuous operation (see Figure 1). The accident helicopter was used for repetitive heavy-lift (RHL) operations at about 165 feet above ground level and was being operated at a height and airspeed combination that had not been demonstrated to permit a successful emergency landing in the event of an engine power loss.

4. The helicopter was operated repeatedly in a hover about 165 feet above ground level, placing the helicopter in the "Avoid Continuous Operation" section of the speed altitude envelope chart. In this area of the chart, an emergency landing is unlikely in the event of an engine power loss.
